Bluebird Canyon Landslide of October 2, 1978,
Laguna Beach, California

By
Russell V. Miller and Siang S. Tan

Miller, R.V. and Tan, S.S., Bluebird Canyon Landslide of October 2, 1978,
Laguna Beach, California: 1979, California Division of Mines and Geology,
California Geology, v. 32, no. 1, p. 5-7.

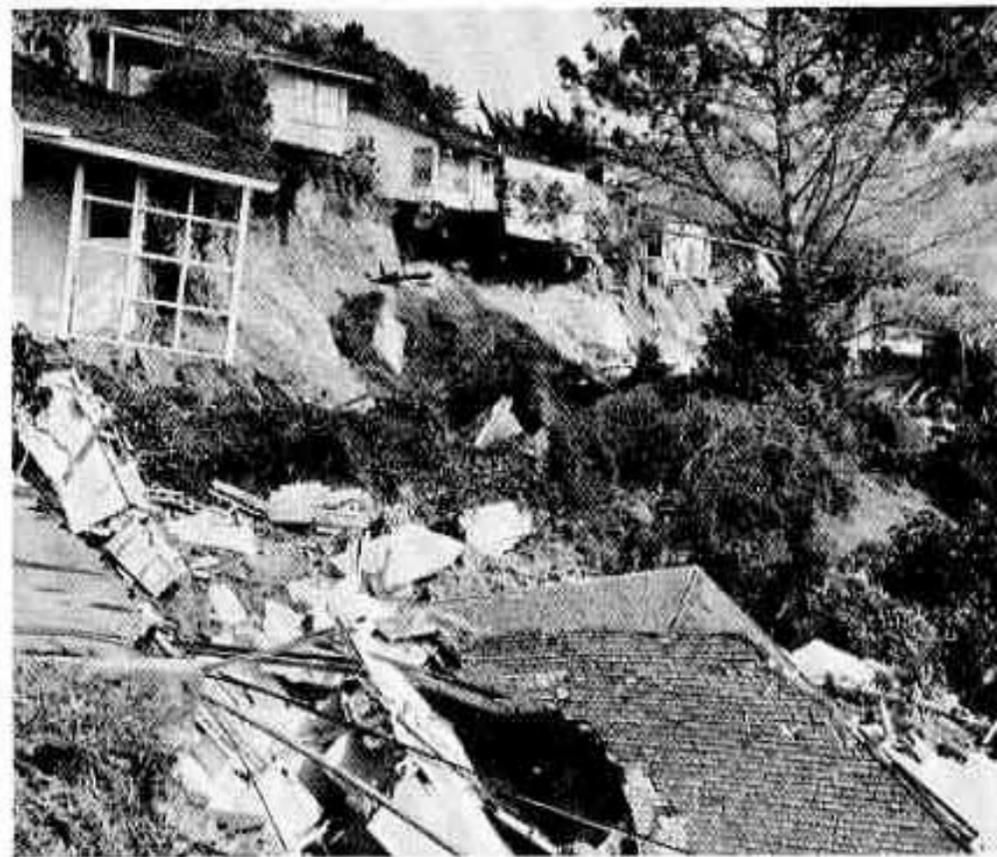
Photo 1. Closeup of headscarp, looking northeast. Arrow pointing to area above concrete slab shows where evidence of older slide plane was found. Exposed bedrock in the headscarp is silty sandstone of the Miocene Topanga Formation. *Photo courtesy City of Laguna Beach.*

Although the Bluebird Canyon landslide covered an area of approximately 3.5 acres, it was suspected by geologists that it was but a portion of a larger, ancient landslide (figure 1). If this was true, the other homes sitting on the unmoved portion of the older slide then were endangered by the possibility of further landslide reactivation. Evidence of the slip surface of this older landslide was found during early examination of the headscarp area of the new slide (photo 1). The landform shown in photo 2 could then be interpreted as possibly the headscarp of this prehistoric slide. In any case the homes immediately uphill from the landslide were in danger from further degrading of the steep headscarp, which is as high as 35 feet.

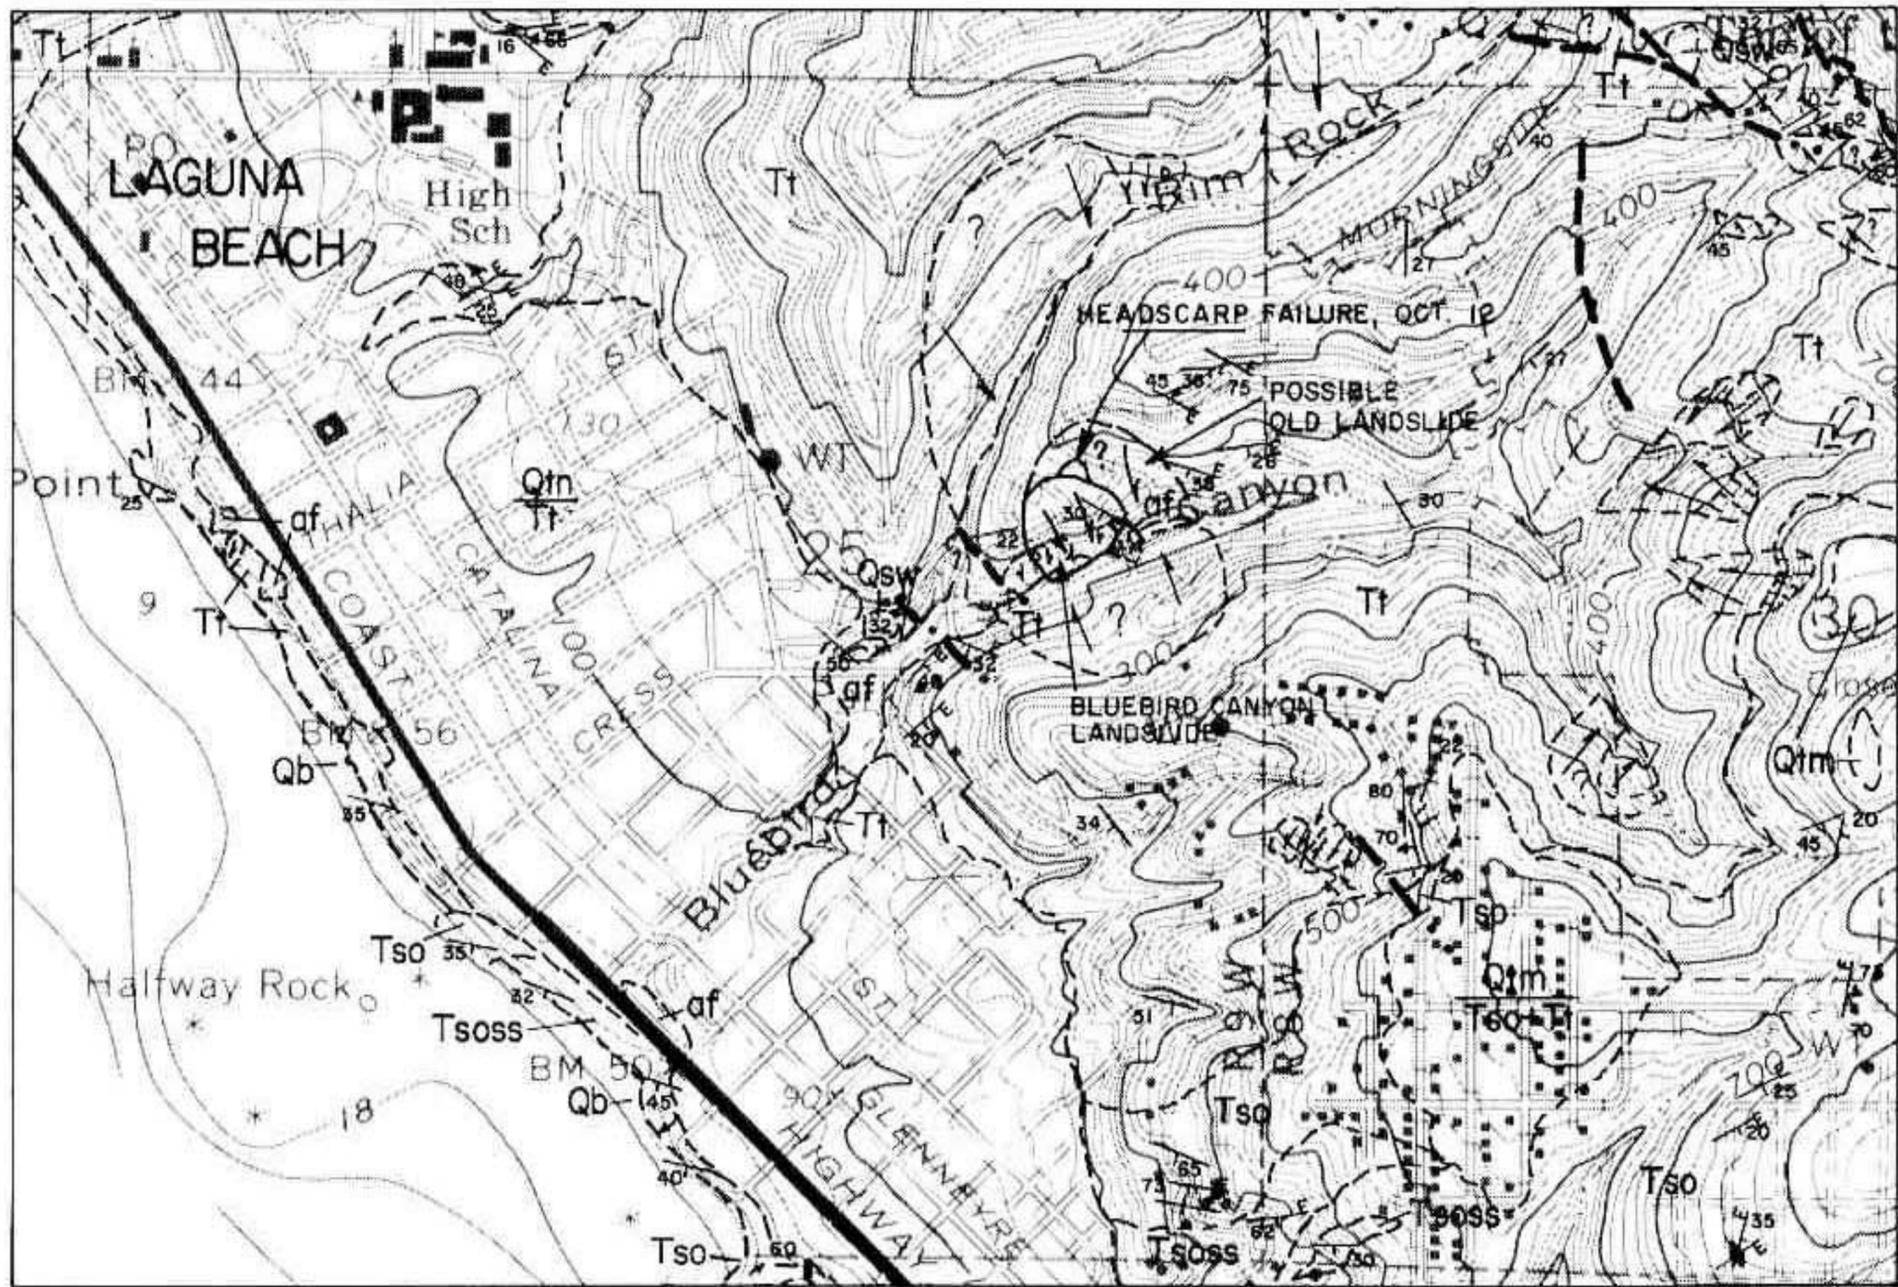
Figure 1. Bluebird Canyon landslide. Map adapted from California Division of Mines and Geology Special Report 127, Plate 1.

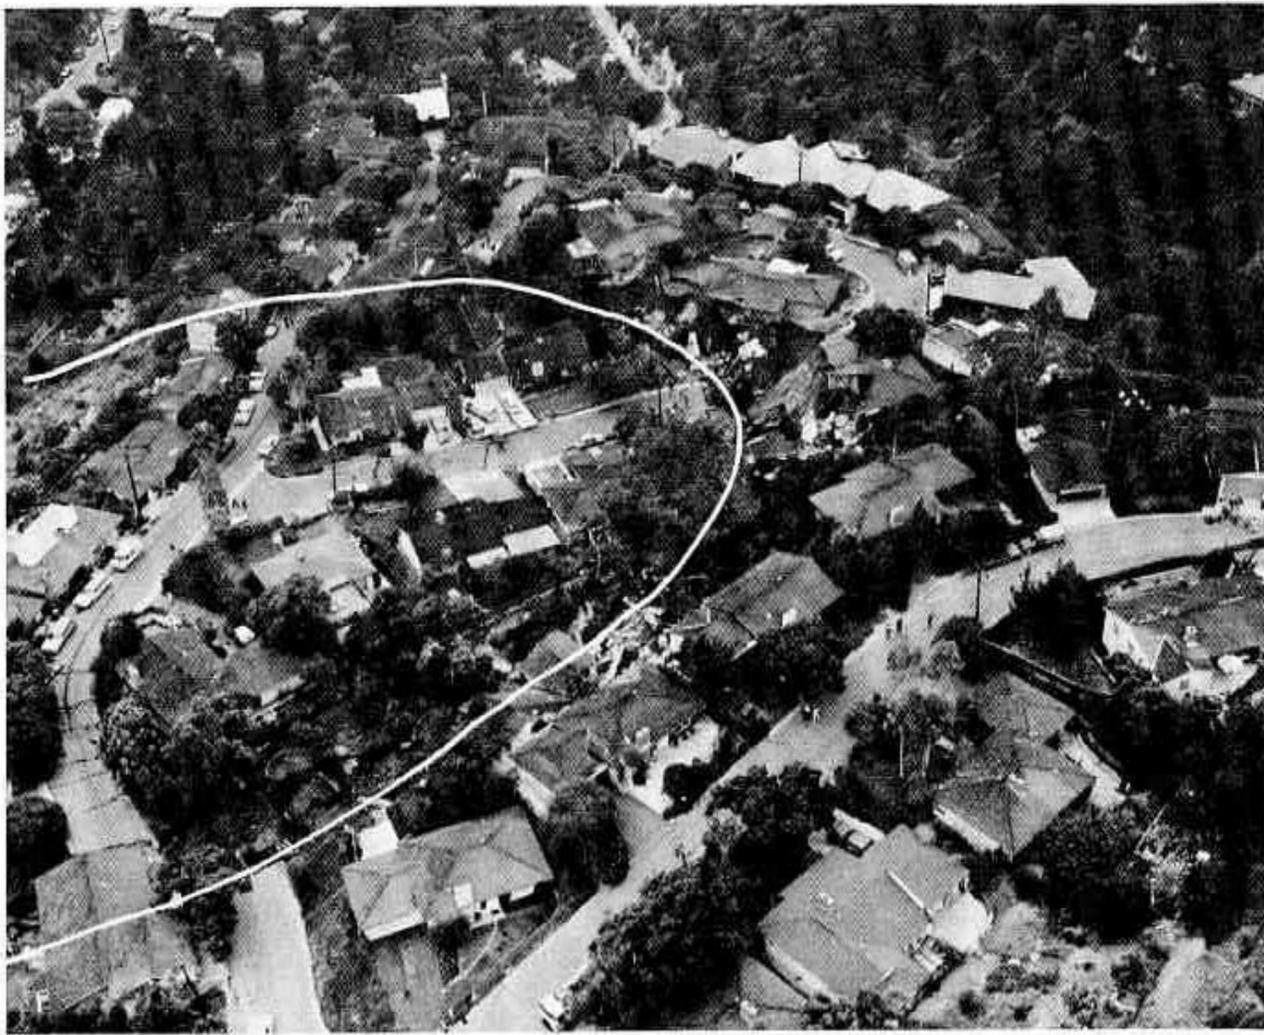
Photo 2. Aerial photo of Bluebird Canyon landslide, looking northeast. *Photo courtesy of City of Laguna Beach.*

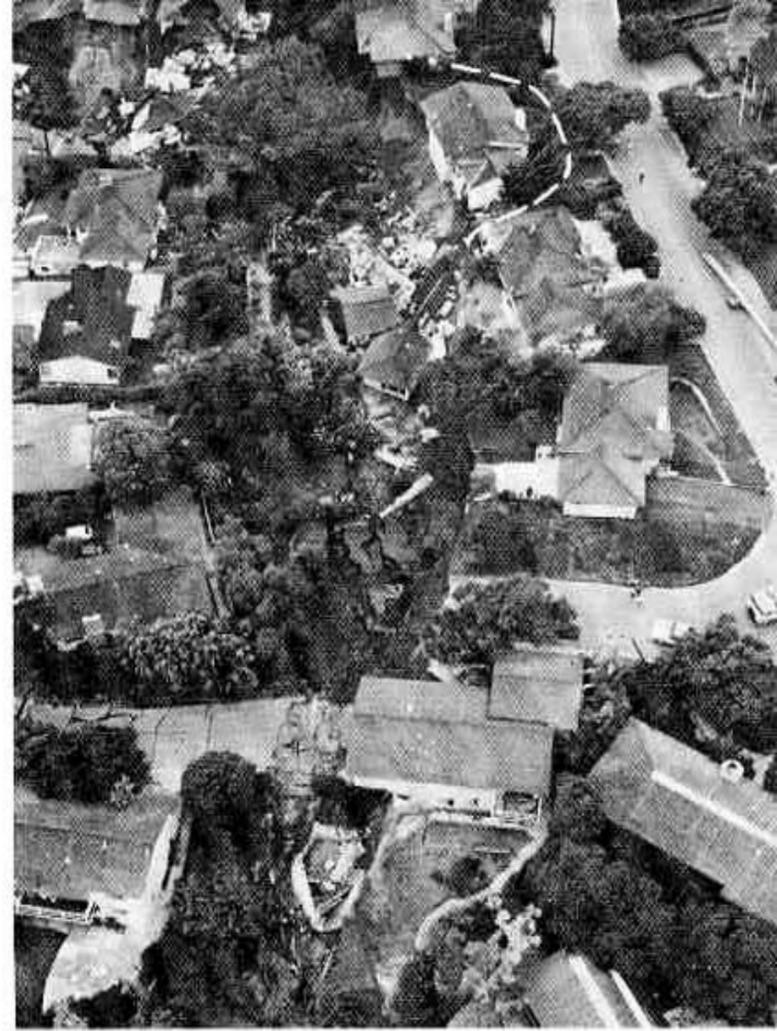
Photo 3. Aerial photo of headscarp area taken the day of the slide (October 2, 1978). Dashed outline is the area which failed 10 days later, illustrating the instability of the ground behind the October 2 headscarp. View looking northeast. *Courtesy of City of Laguna Beach.*

On October 12, ten days after the slide began moving, a small section of ground gave way in the headscarp, taking with it another house (photo 3).

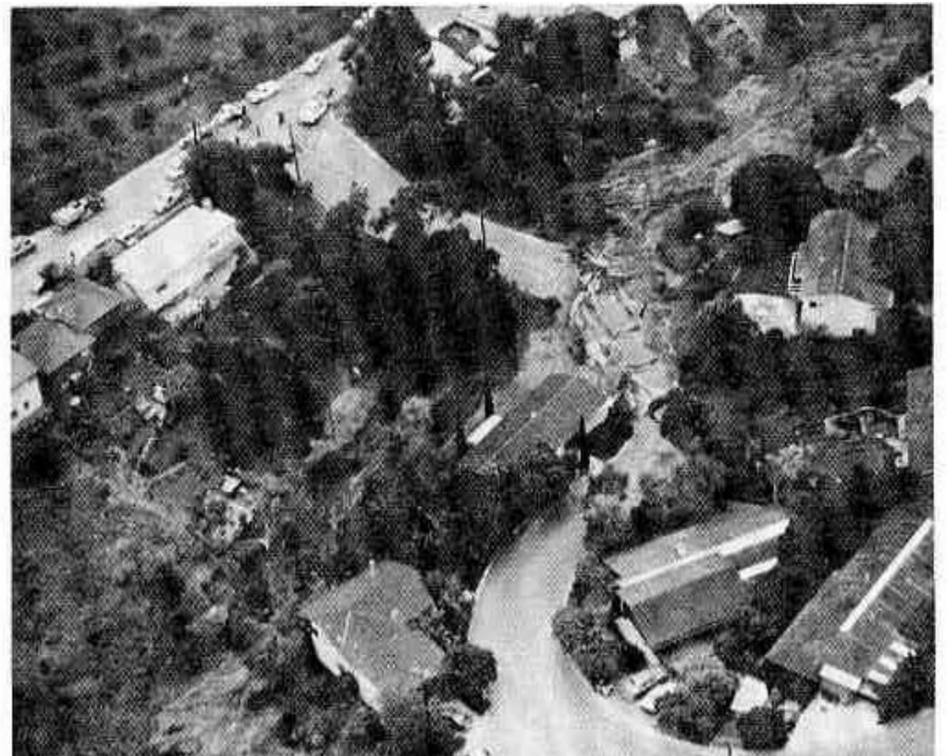
Photo 5. Aerial photo of easternmost toe area of slide. Note buttrressing effect of road fill ("af" on figure 1) where Oriole Drive crosses Bluebird Canyon. View toward the southwest. *Photo courtesy City of Laguna Beach.*

The Bluebird Canyon landslide was determined to be a "block glide" or "rock block" slide — a slide with little or no rotational movement. The slide mass remains fairly intact during its descent (photos 4, 5).
